Understanding Switchboard Arcing Faults

*H. Bruce Land, III
March 2009*

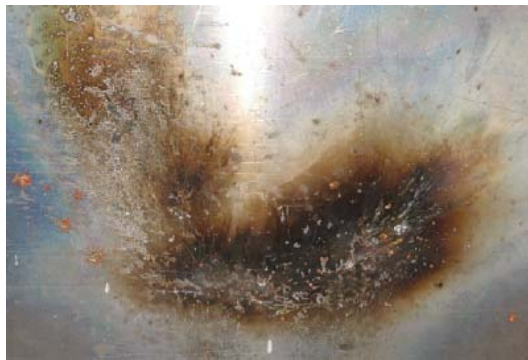
Very Short Duration Arcs (100ms @ 3700A)

- Arc initiated on the three bus $\frac{3}{4}$ " from the side of the switchboard
- Switchboard was ungrounded with respect to the power system
- Arc moves rapidly from spot to spot in a random fashion
- Smoke damage
- Figure of merit for testing was the time to burn through the side of the switchboard

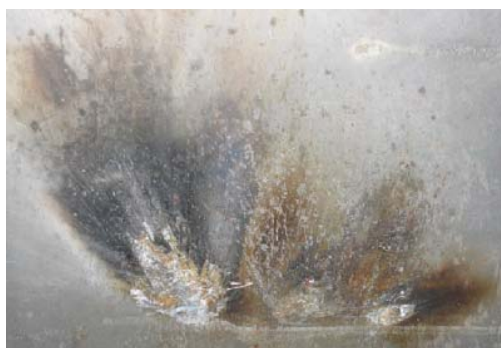
Slightly Longer Duration Arcs (350ms@3600A)

- Arc motion becomes a weighted random function
- Arc contact returns to certain areas causing damage to the surface
- Pitting and pooling occurs on the surface

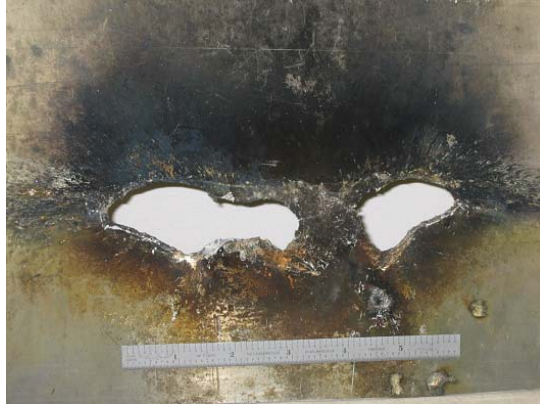
4,800A Arc for 0.4 Seconds

- Arc attaches to edges of pits and tips of pools until a hole appears in the side of the switchboard
- Arc works the edges of the hole as it unzips the hole larger
- Edges of holes are very sharp
- 450 VAC 3 phase AC arc at 4800 A for 0.4 seconds
- Arc passes from phase to side panel and back to phase as the plasma expands

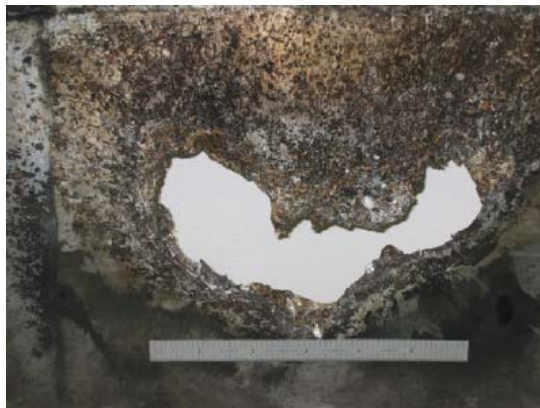
4,100 A Arc for 0.7 Seconds

- Six inch hole in the side of the switchboard
- This is collateral damage
- Similar amounts of material missing from the bus bars
- Damage rate accelerates with time until the switchboard is destroyed

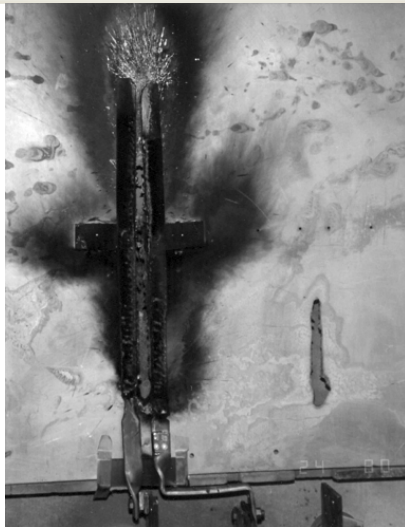
Bus Bar Insulation

- Arc temperatures ~ 20,000 °C
- Sun temperature ~5,000 °C
- Insulation will not quench an arc
- Tests conducted at 155 VDC with 1/2" bus bar spacing
- Ionization of insulation lowers the resistance of the air and increases the current
- Insulation does protect against fallen objects, but the lower the mass of the insulation the better
- Test results repeated with Glyptal, fiberglass cloth, and Nomex
- Insulation exacerbated the fire

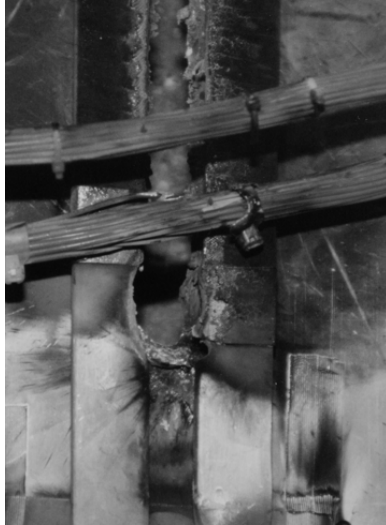
Obstructions

- Bus bar supports or wire bundles can cause plasma to collect and “pool”
- Pooling of plasma increases the temperature and lowers the arc resistance which increases the current
- Damage increases dramatically when the plasma is allowed to pool

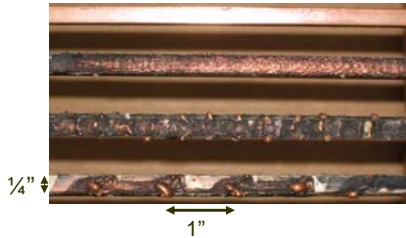
Evolution of Arc Tracks (Barbs) on Bus Bars

- Arc moves rapidly along the bus bars due to the magnetic forces
- Velocities of 1000 ft/sec typical for 7000A arcs
- Temperatures where the arc contacts the conductor are ~20,000°C
- Copper melts & solidifies into small barbs due to surface tension of the liquid copper
- High speed arcs leave small sharp barbs
- Arc Tracks may be too small to see with the unassisted eye
- Arc Tracks help to backtrack the arc to its origin

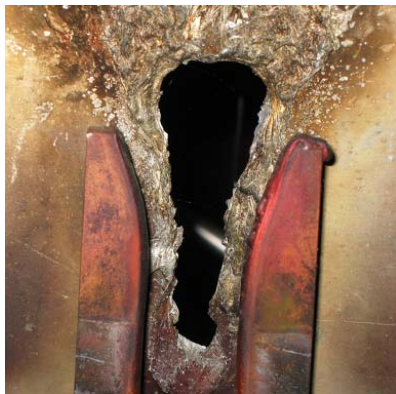
Arc Restrike on Vertical Bus Bars

- Arcs move away from the source of the current
- Arcs attach to the most distant end of the bus bars
- Plasma cloud billows out from the arc channel
- Arc involves adjacent conductive material as an incidental conductor
- Arc moves up the switchboard side until the path length is too long for the applied voltage
- Arc restrikes lower on the bus bar
- Process repeats, enlarging the damaged area

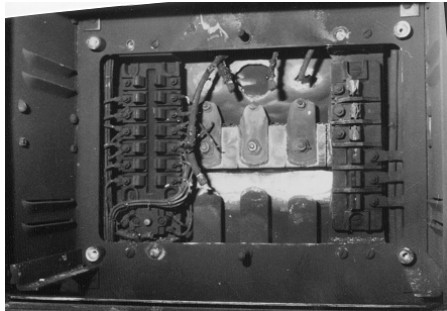
Case 1: Optimum Manual Intervention

2.5" Bus with 1.75" between them

- Crew in position for emergency drill at that time
- Crew immediately opened turbine generator breaker
- Covers blown off by pressure
- Holes through the rear of switchboard at bus bar tips
- Bus bars cut and larger hole under the insulator 6" below
- Arc splatter found 15 feet away
- Damage found to breaker stabs
- Crew felt that faulty breaker stabs were the root cause

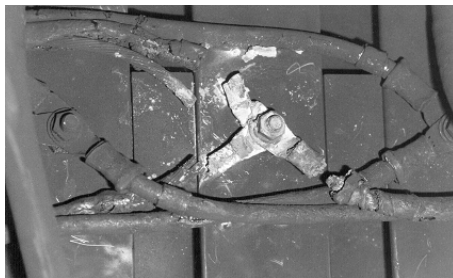
Case 1: Arc Origin

**Root Cause of Case 1:
Faulty crimp caused in-line arc**

- Entire inside of switchboard was black with soot
- Arc tracks (barbs) led lower into the switchboard
- Investigated which loads were energized at the time of the event
- Faulty lower left crimp caused localized overheating, melting the cable, resulting in an arc
- IR imaging of no assistance
- Magnetic forces caused the cables supplying this switchboard to burst 75 pound cable ties in the supply switchboard

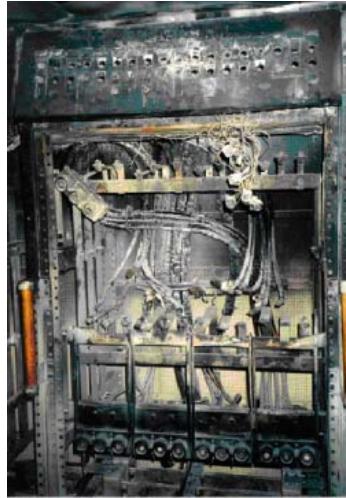
Case 2: Front of one of the Switchboards

- Ship was at sea under steady normal power
- Billowing sparks and arc flames drove crew from the switchboard compartment
- Generators were seen jumping on motor mounts before being manually shut down
- Ship towed to port
- Crew blamed arcing on voltage spikes from hopping generators
- Spikes can cause arcing, but spikes are rare aboard ship
- Paschen's Law shows the limits of this possible cause

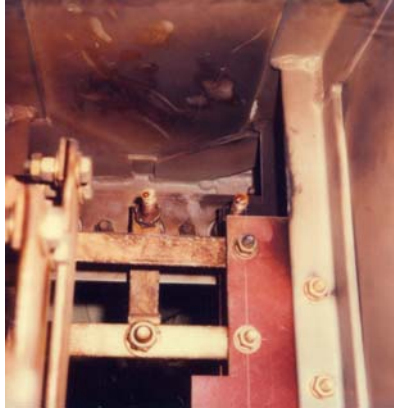
Case 3: Top of Switchboard

- Ship responding to a flank speed bell
- Sudden noise, flash of light, and loss of power
- Light smoke damage to top inside of switchboard
- Damage limited to the tip of two bolts
- Automatic Arc Fault Detection System opened all supply breakers in <0.2 sec, minimizing damage
- No other damage immediately apparent

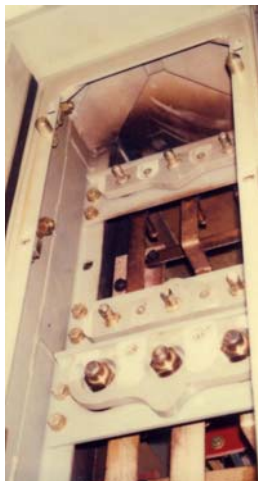
Case 3: Front of Switchboard

- Note that the entire inside of the switchboard was not covered in soot as with most arcing events.
- Compare damage here with that of manual intervention in Case #1
- Automatic response of Arc Fault Detection (AFD) System limited damage
- Crew surmised that a faulty breaker in the top of the board started the arc

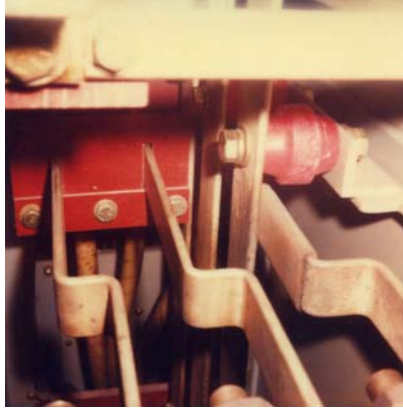
Case 3: Middle of Switchboard

- Drill shaving found on bus support 1/3 down the switchboard
- Arc tracks, too small to be seen without magnification, began on two phases just below the bus support and led to the top of the switchboard
- Can drill shavings initiate an arc?

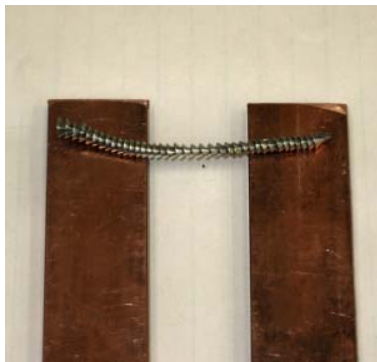
Case 3: Cause

- Aluminum drill shaving similar to that found inside of the switchboard
- Testing confirmed that drill shavings can initiate an arc

**Root Cause of Case #3:
Inadequate inspection resulted in loose conductive material in the switchboard**
