Understanding Switchboard Arcing Faults

*H. Bruce Land, III
March 2009*

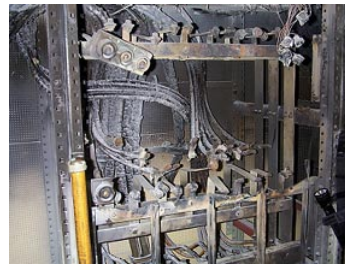
Main power distribution switchboards can be reduced to scrap in seconds by arcing faults with currents too small to trip the main circuit breakers.

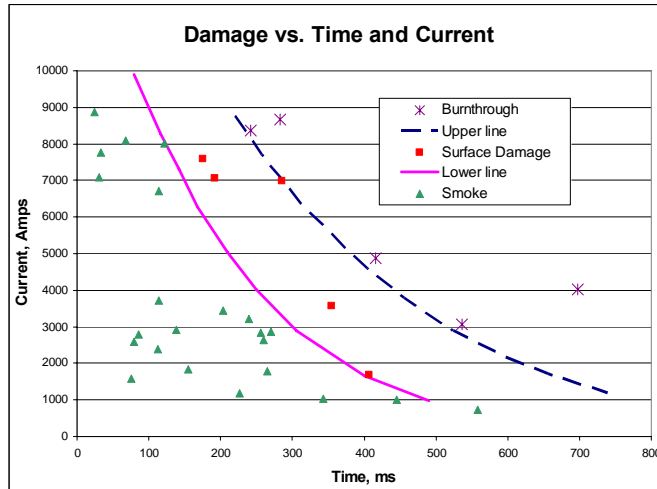
Arc Damage Progression within a 450 VAC Switchboard

- Six inch hole in the side of the switchboard
- This is collateral damage
- Similar amounts of material missing from the bus bars
- Damage rate accelerates with time until the switchboard is destroyed

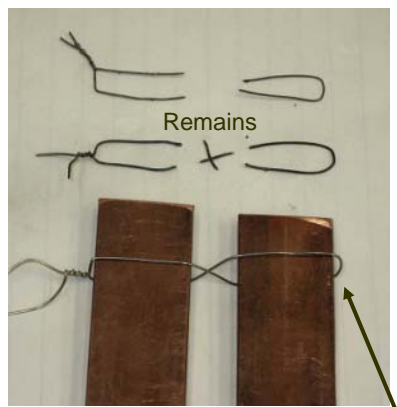
Initial Position

- 20 Awg copper wire stretched between bus bars
- Current applied
- High current through a small wire creates enough plasma to initiate the arc over wide gaps
- The center wire remains are usually recoverable, but sometimes they are completely vaporized
- The outside pieces of the starter wire are always recoverable
